SNAP-8 REFRACTORY BOILER
DEVELOPMENT PROGRAM

by R. A. Fuller

GENERAL ELECTRIC COMPANY

NATIONAL AERONAUTICS AND SPACE ADMINISTRATION • WASHINGTON, D. C. • APRIL 1974

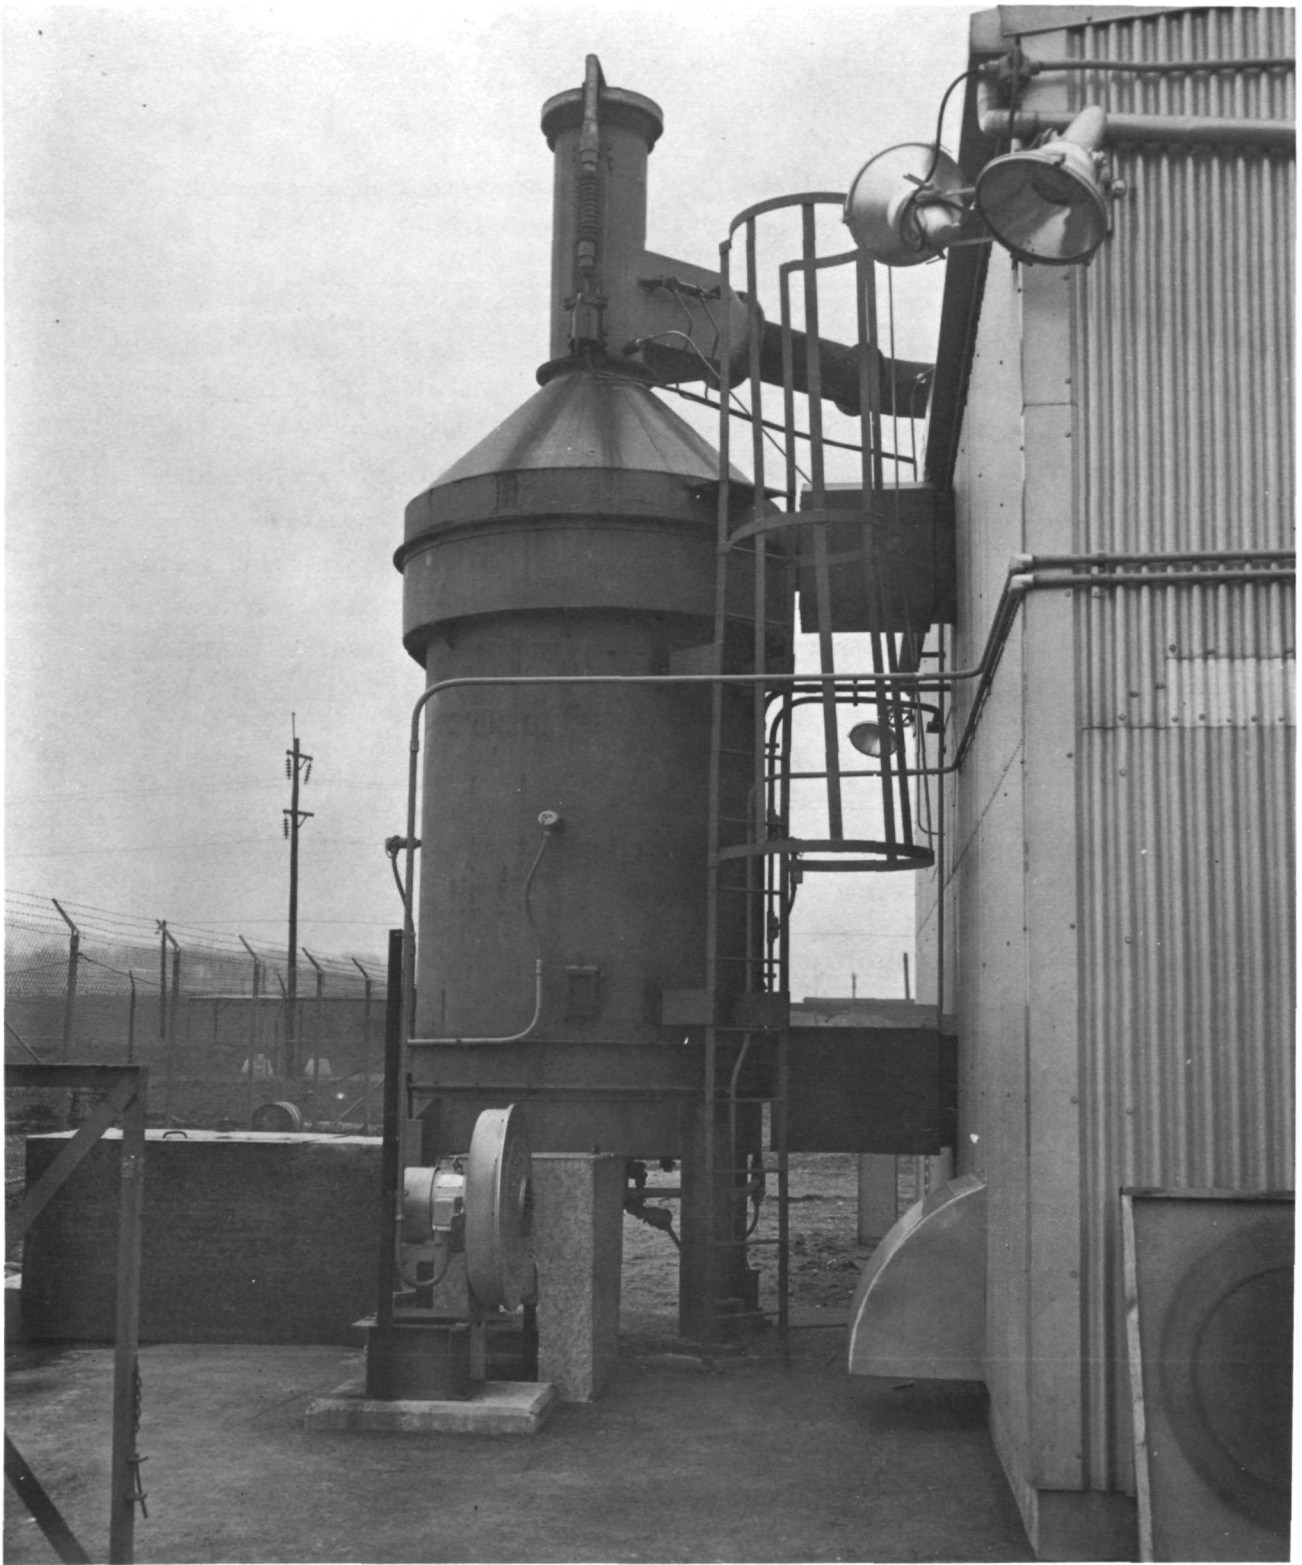
Figure 3. Installation of facility gas fired heater.

The heater efficiency is approximately 30% and a large fraction of excess air is used to avoid carburization of the L-605 tube bundle and to limit flame temperature.

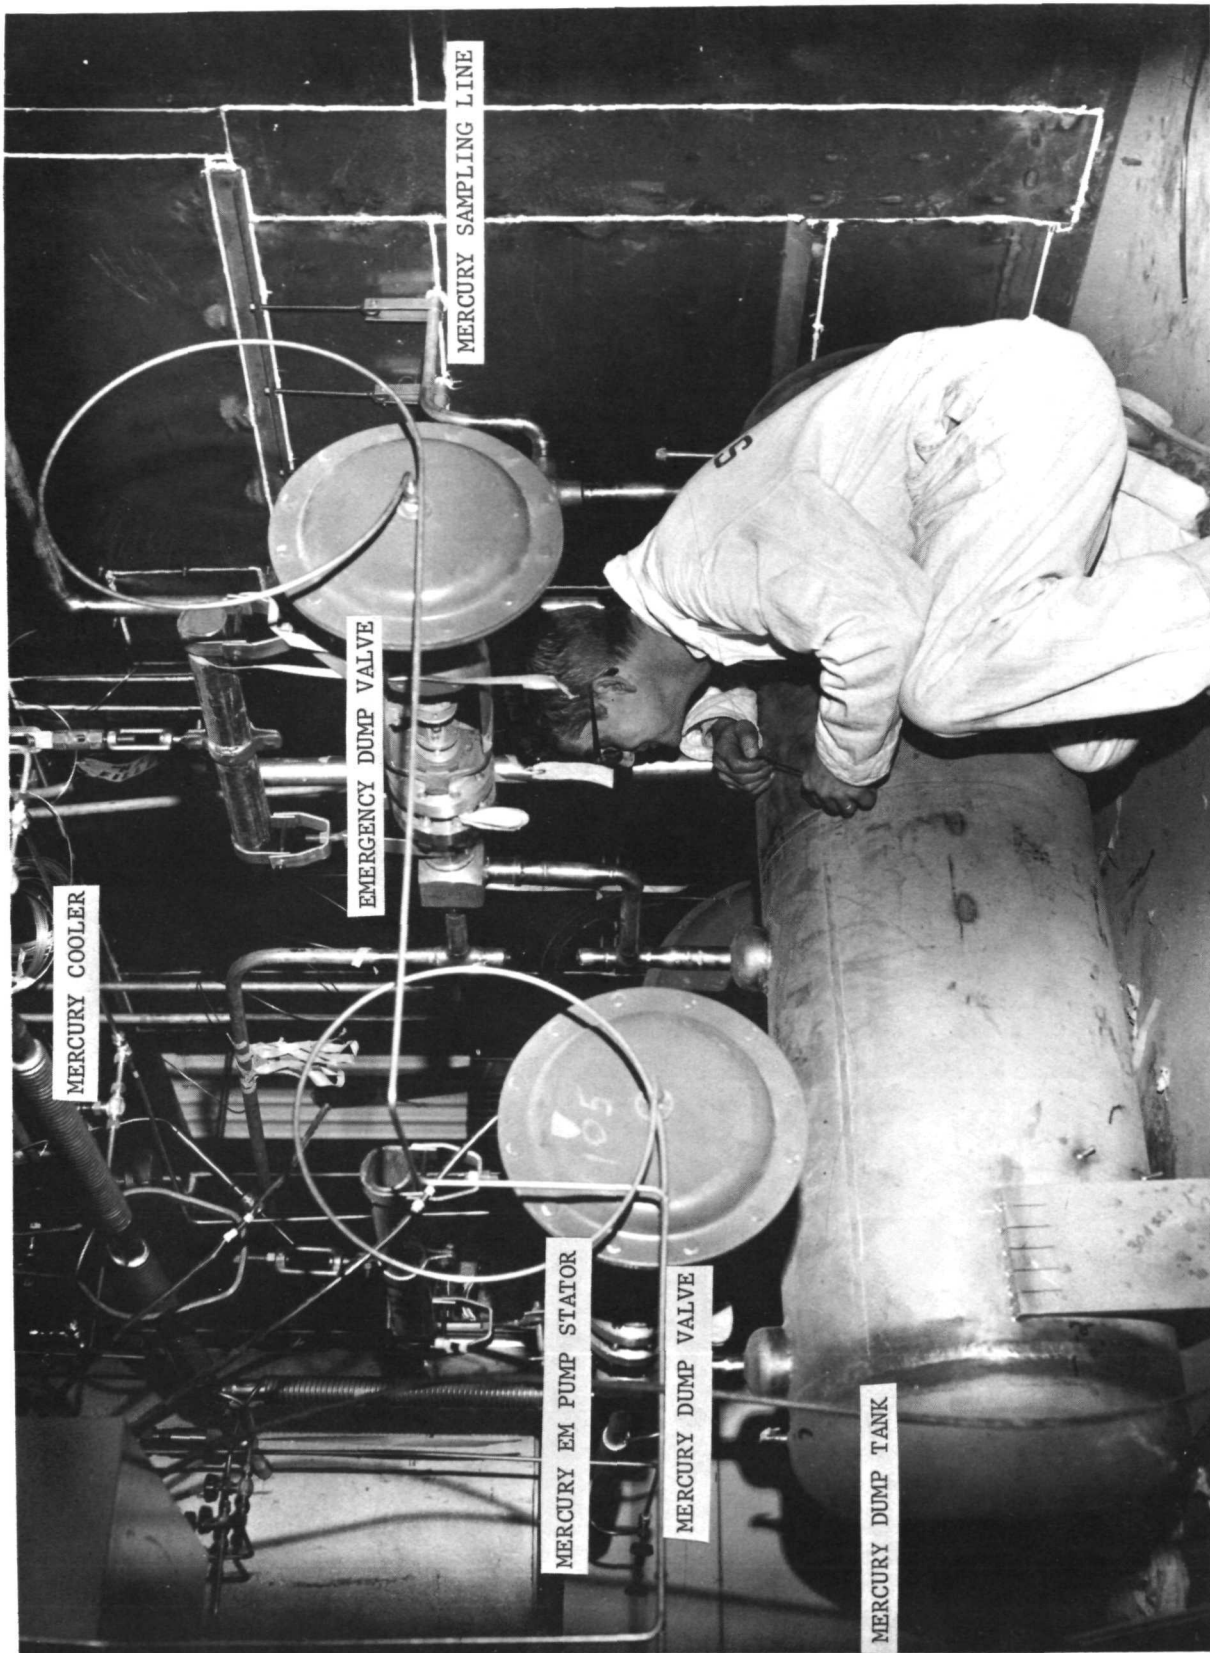
Figure 14. SNAP-8 refractory boiler development facility showing mercury dump tank with dump valves, EM pump stator, and sampling line.

Dump Tank - The mercury dump tank installation, shown in Figure 14, consists of a section of 18-inch diameter by 0.250-inch thick L-605 with 18-inch caps welded at each end. This tank was reworked from an earlier test program. Attached to the dump tank are the necessary loop fill and drain line, argon and vacuum vent lines, emergency dump line and tank fill and drain line.

Mercury Subcooler - The mercury subcooler, shown in Figure 14, consisted of a 1/4-inch tube helically wrapped and brazed to the 3/4-inch pipe line that ran from the condenser to the mercury pump and from the pump to the liquid throttle valve. The purpose of these coolers were to trim the mercury temperature to the pump suction to prevent cavitation at low condensing pressures and to control the boiler mercury inlet temperature.

Sampling System - Also shown in Figure 14 is the mercury sample line which is connected to a sample valve external to the enclosure for sampling during operation. Also provided at the sample station are valved argon and vacuum lines.

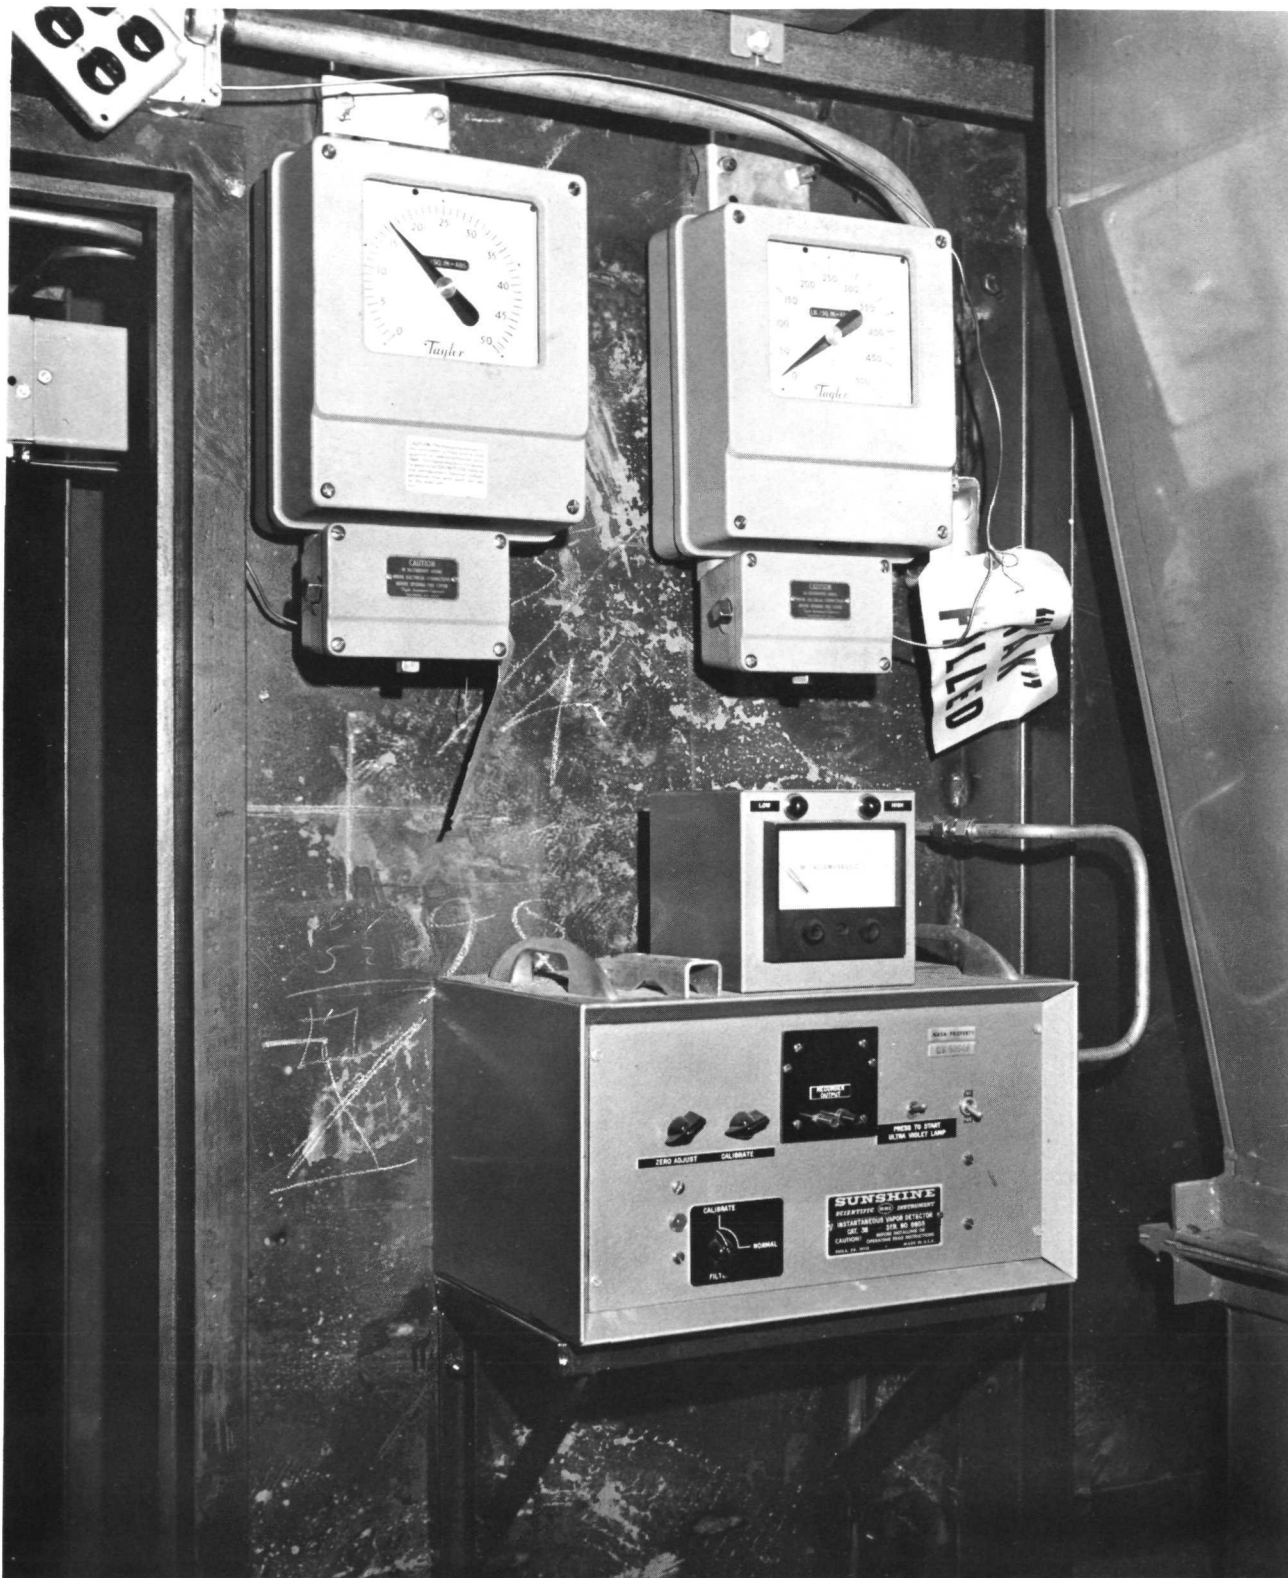
Figure 25. SNAP-8 refractory boiler development facility showing mercury vapor detector and mercury pressure gages.

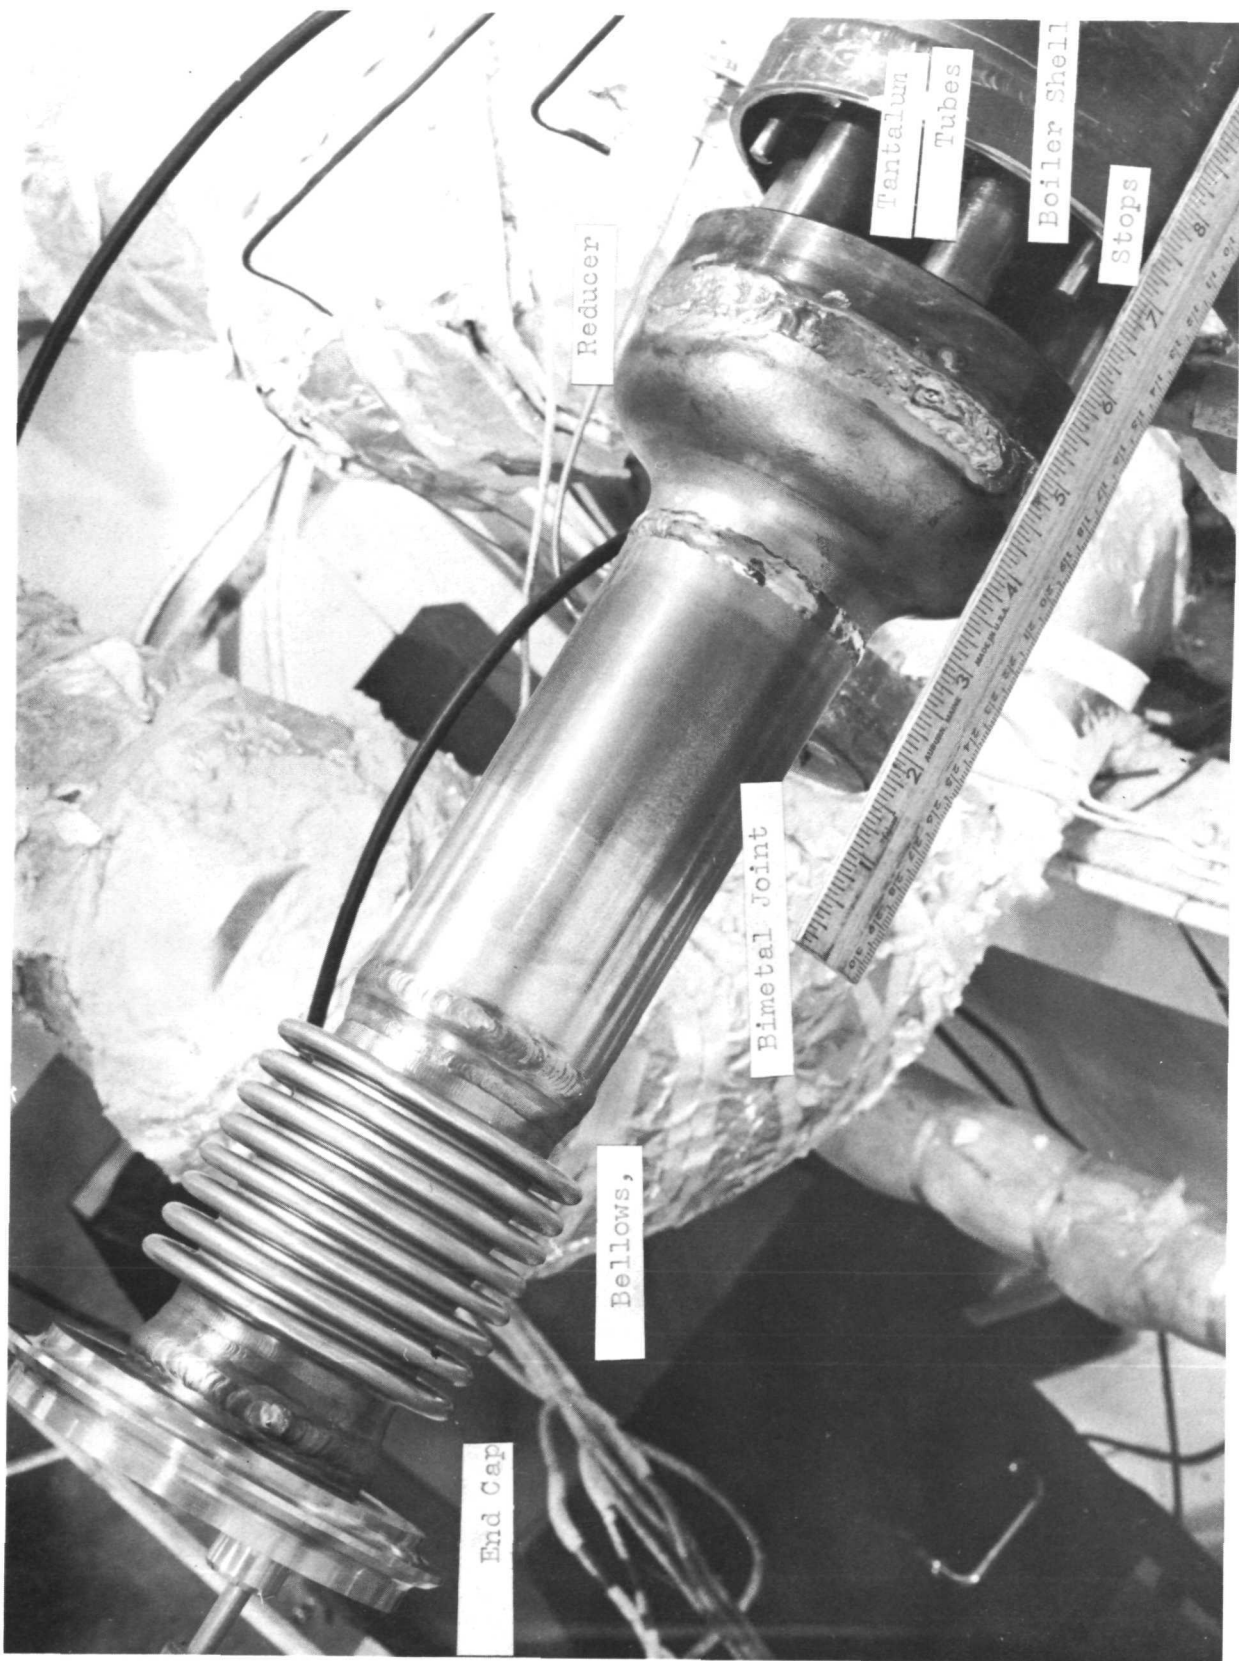
Figure 35. SNAP-8 refractory metal boiler repair showing end plate, bellows, bimetal joint, tantalum reducer installed.

The failure of the mercury inlet tantalum/stainless steel transition joint required the rebuilding of the test boiler in the field. This rebuild included the recentering of the tube bundle within the shell, at which time a heavy deposit was discovered and removed from the tube bundle in the high heat transfer region. Subsequent tests showed a marked improvement in thermal performance as well as an improvement in the circumferential shell thermal gradient.

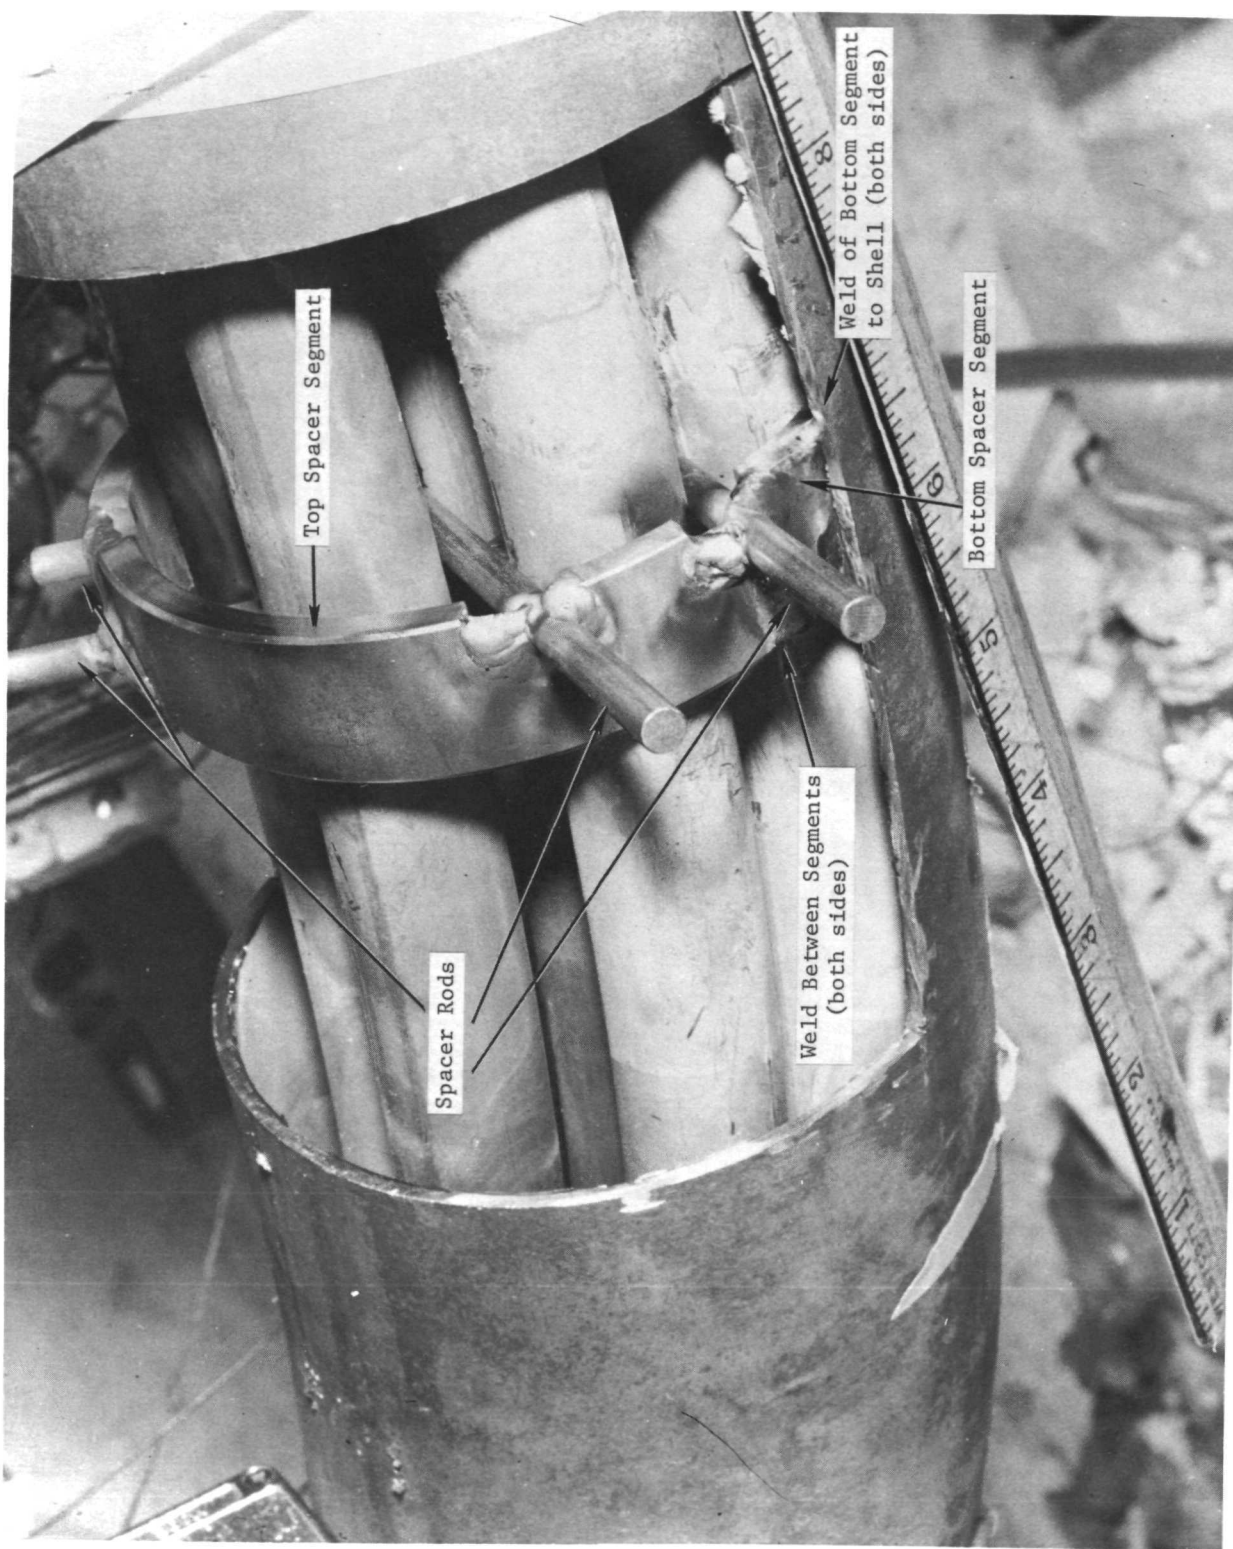
Figure 37. SNAP-8 boiler - typical shell side spacer installation.

At this time, NASA-LeRC decided to attempt to recenter the tube bundle by incorporating 5 new shell spacers into the boiler shell. Segments of the shell were removed to accommodate the spacer installation. A typical spacer installation is shown in Figure 37. The spacer consists of two 180° spacer segments with 4 spacer rods inserted through the tube bundle to maintain tube positions. The rods were welded to the segments and the segments were welded to the shell. Subsequent radiographic inspection indicated an improvement in the tube bundle position.

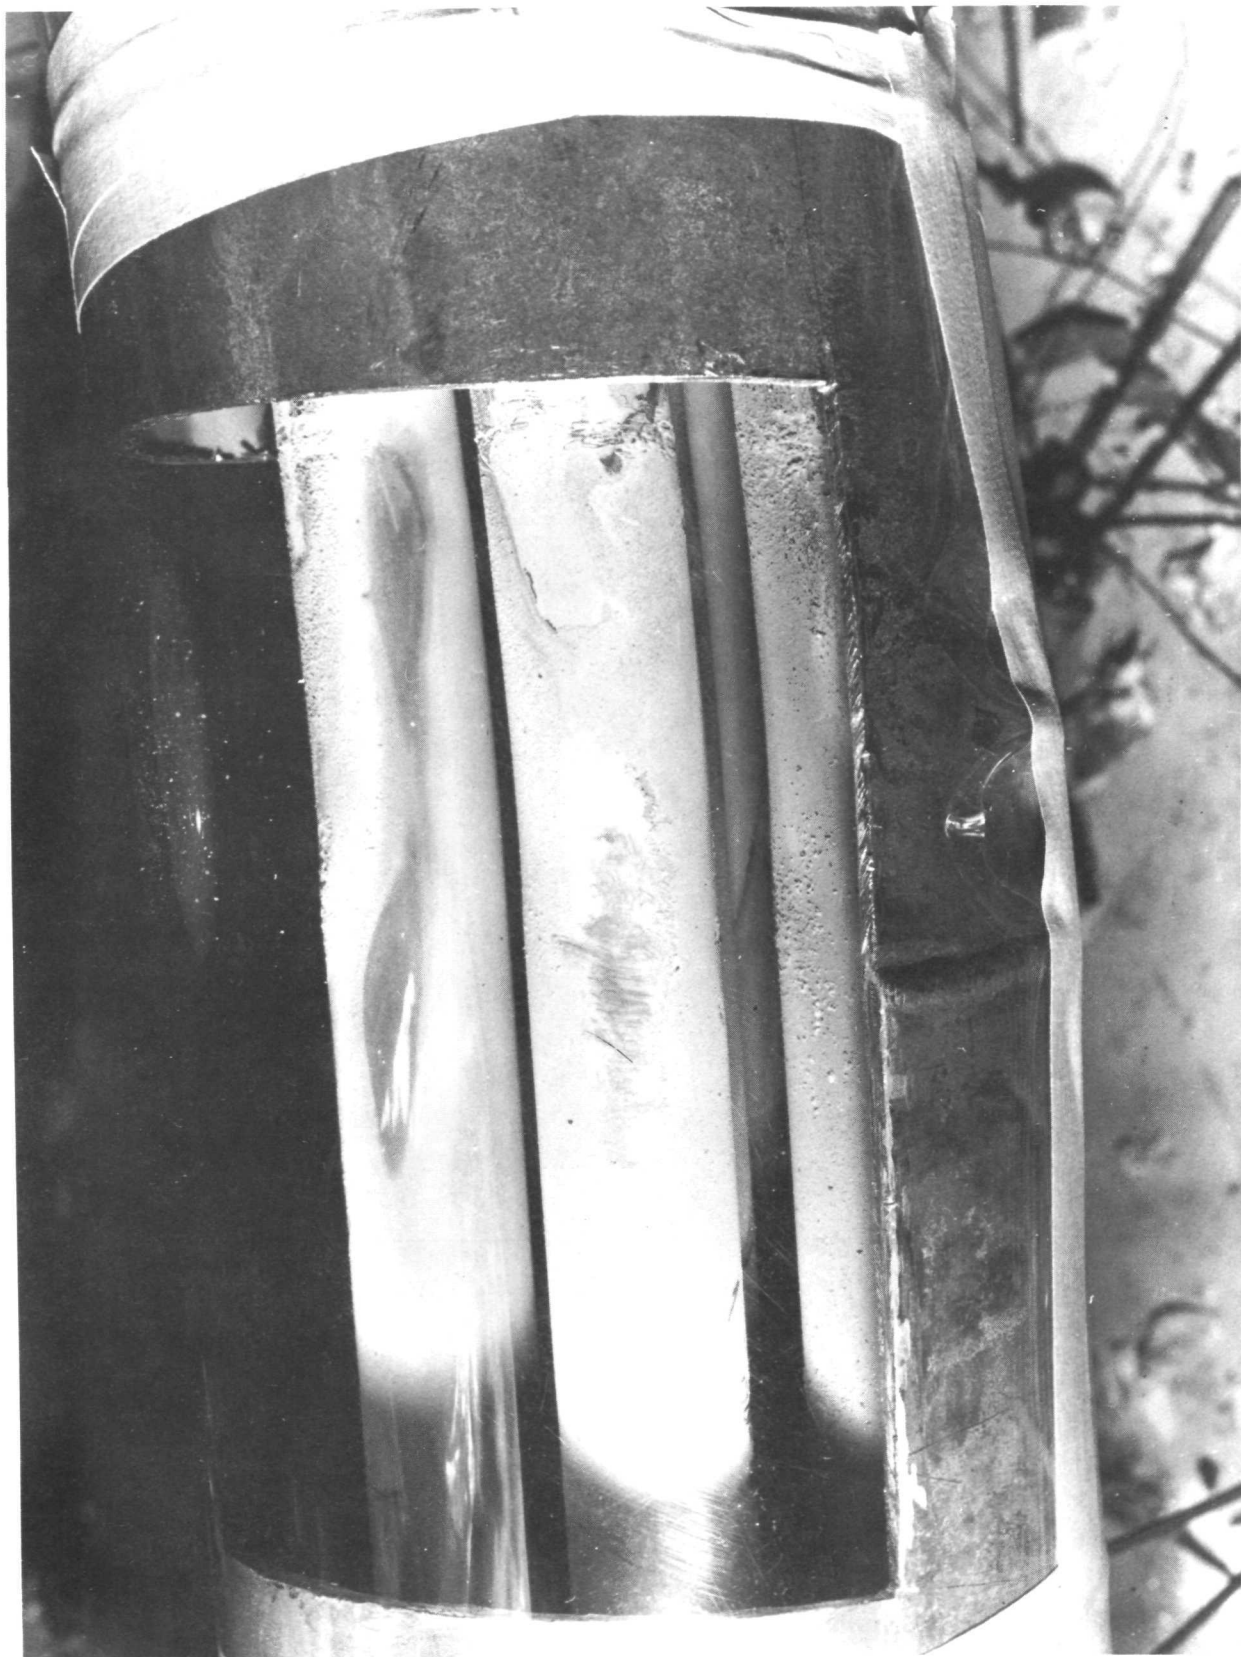
Figure 38. SNAP-8 refractory boiler SN-1 with shell open showing oxide deposits in the plug region.

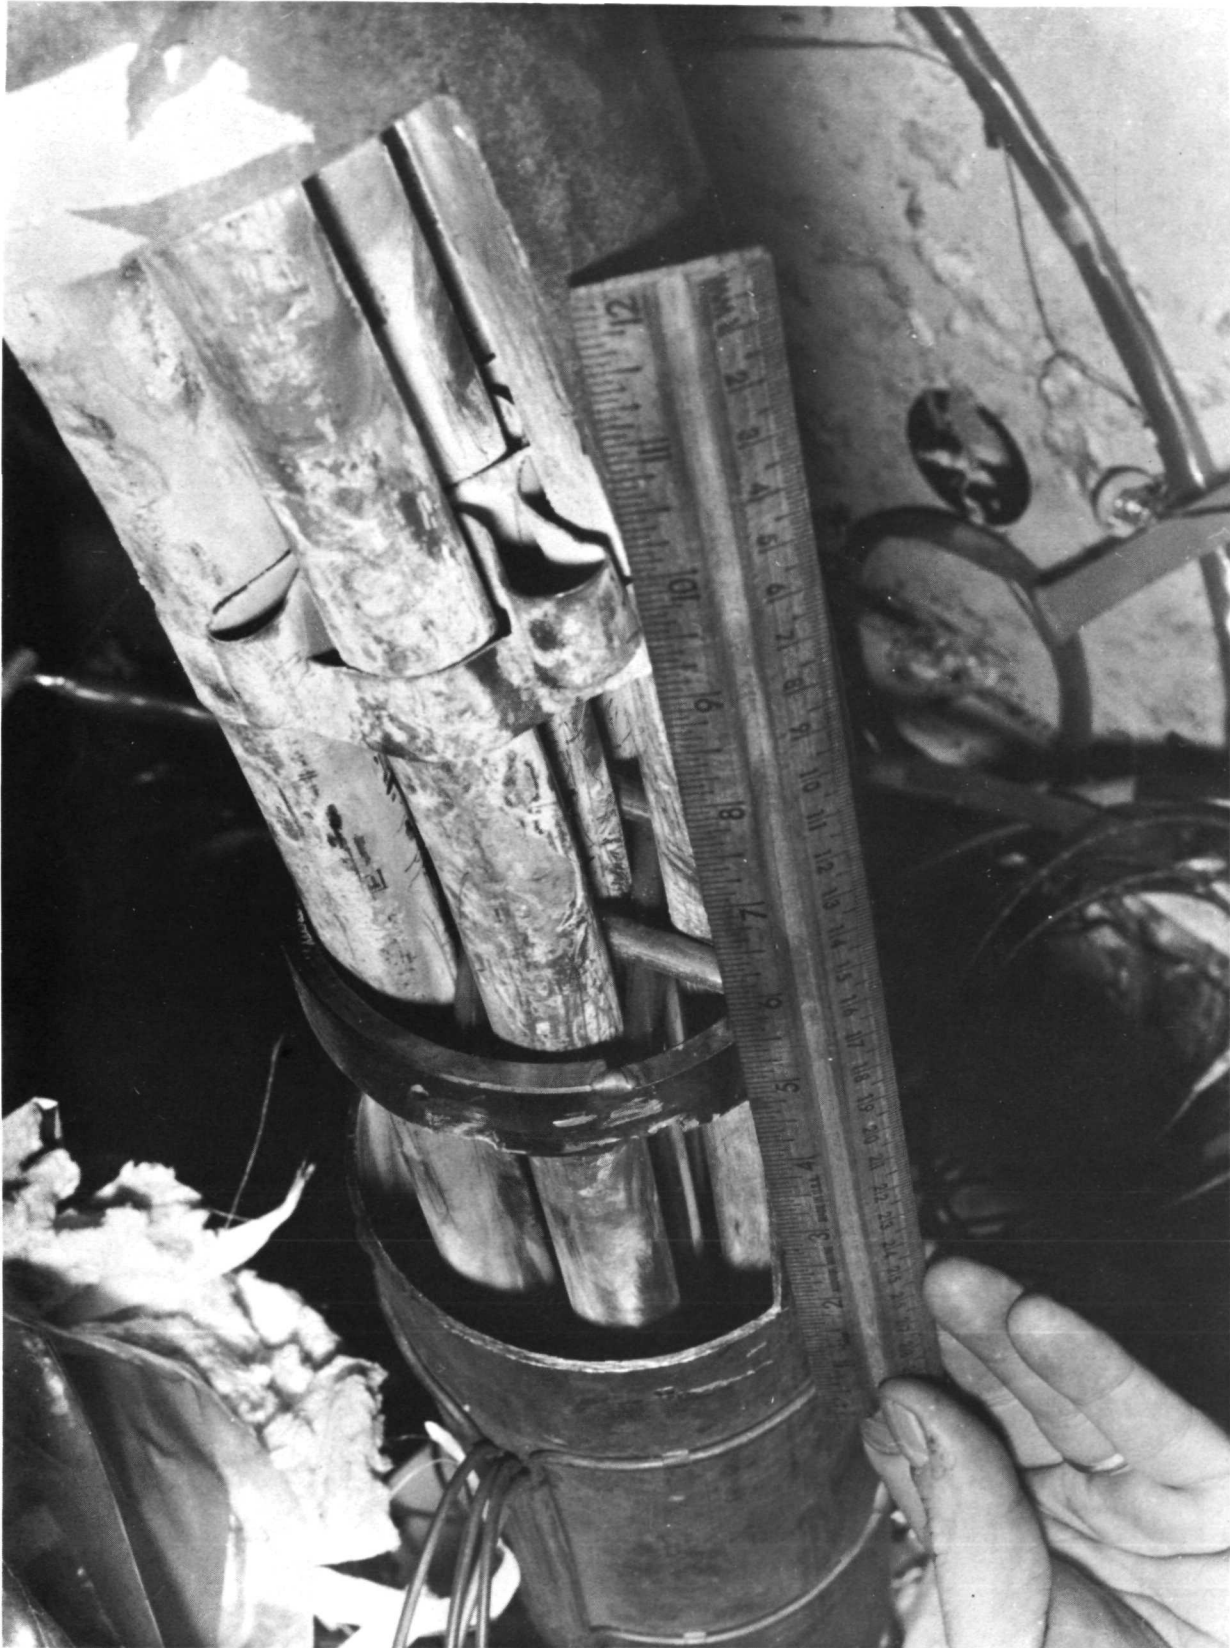
Figure 39. SNAP-8 refractory boiler SN-1 with deposits removed and new tube supports installed.

Discovered during the spacer installation was a heavy deposit on the primary NaK side of the stainless steel tubes. This deposit, shown in Figure 38, was wire brushed off and the tubes cleaned as shown in Figure 39. Figure 39 also shows one of the original spacers which had not been removed along with one of the new spacers. The old spacer indicates some distortion. Following radiographic and mass spectrometer testing to assure boiler integrity, the boiler was placed on test.

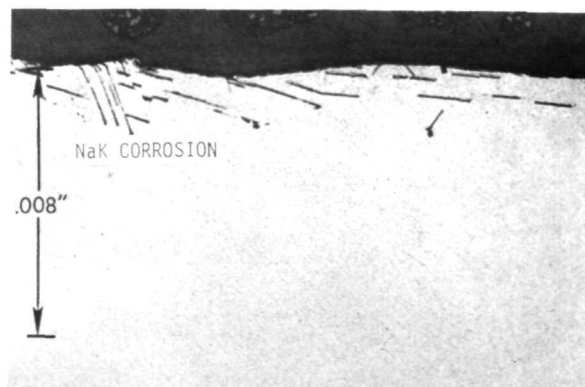
NaK CORROSION ON THE
STATIC NaK SIDE OF THE
TANTALUM DISHED HEAD

CRACKS AT THE SURFACE
OF THE ORIFICE
(TRANSVERSE SECTION)

Figure 122. Post-test microstructures of the tantalum at the boiler inlet.

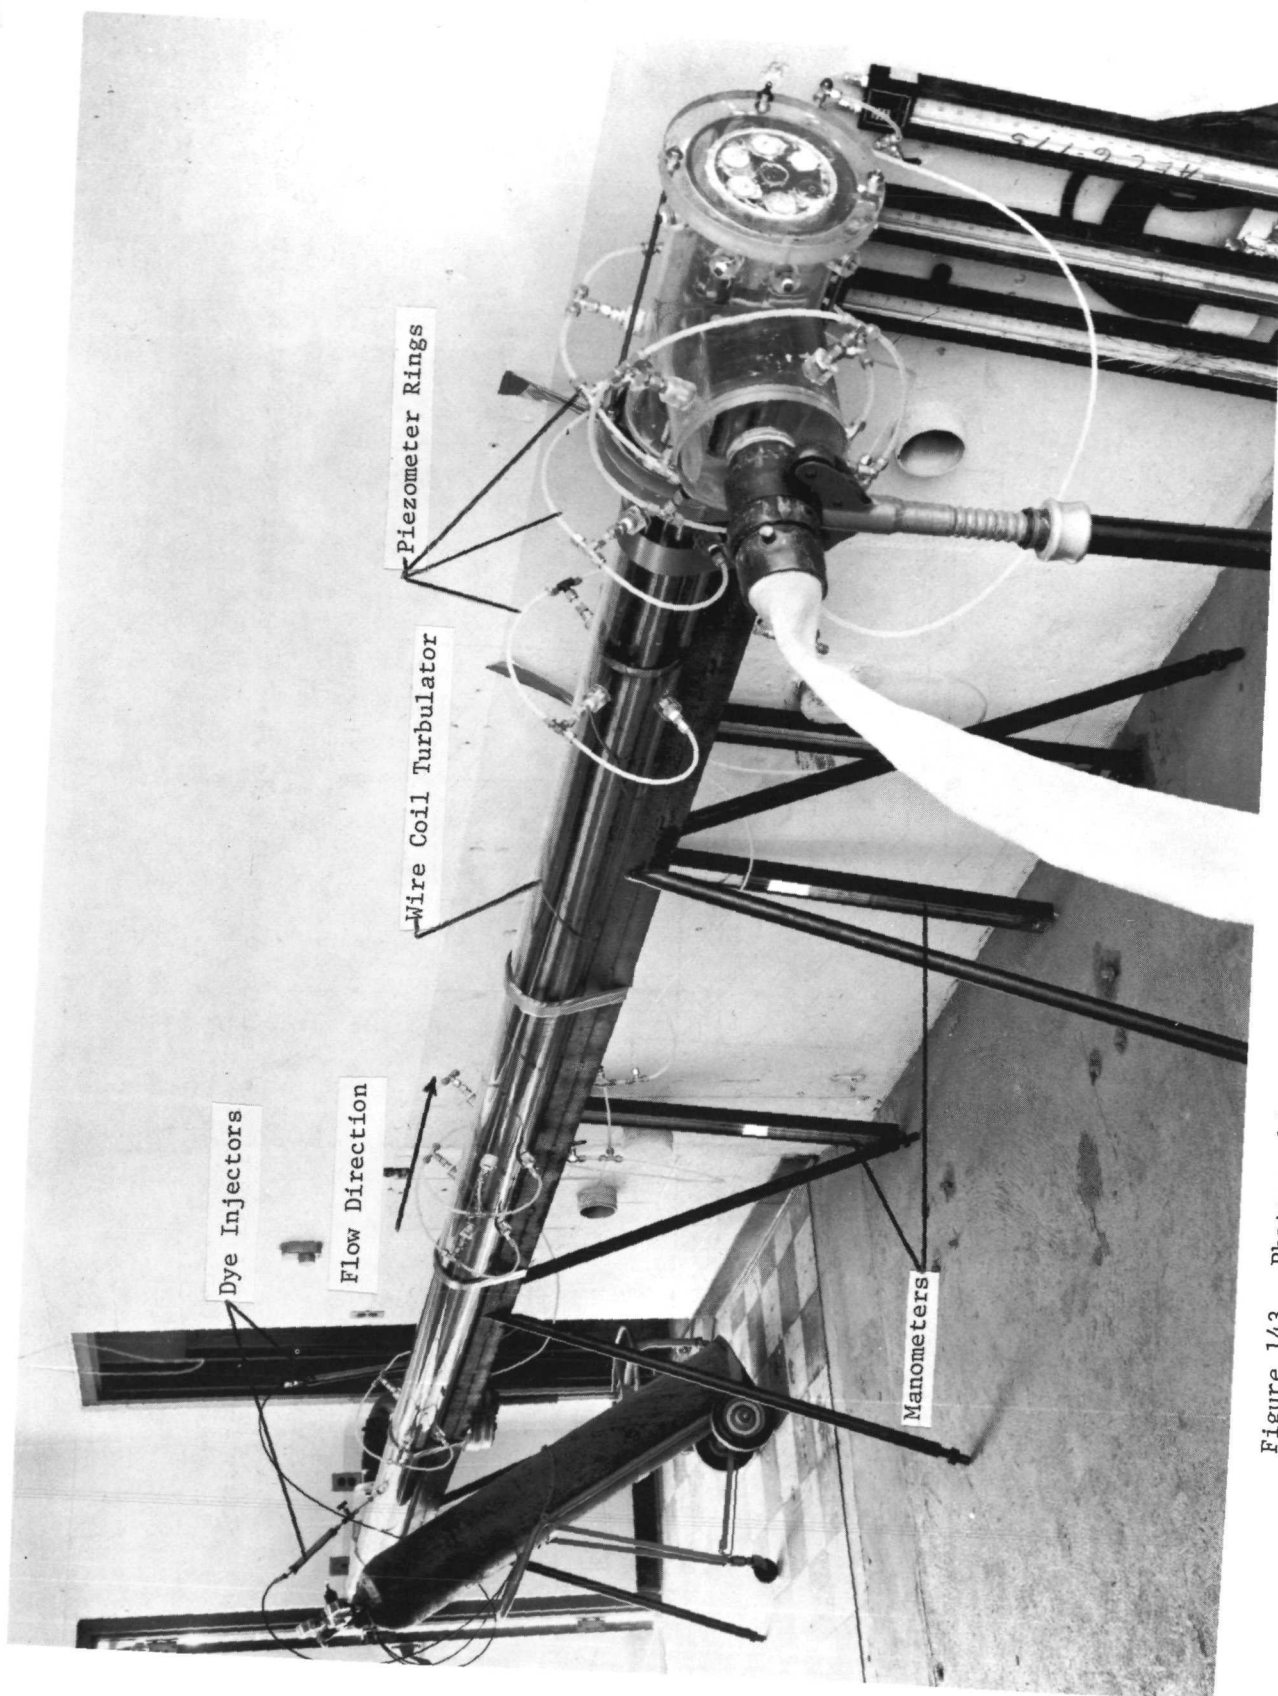
Figure 143. Photographic view of SNAP-8 boiler shell side hydraulic tests.

Shown in Figure 141 is an illustration showing the lack of mixing at the NaK exit of the boiler. This poor mixing is a good reason for the poor shell temperature distribution in this area. The temperature distribution from boiler testing is shown in Figure 142. A plexiglass flow model (Figure 143) was constructed to provide a manifold at the exit to promote good mixing. The manifold was tested, and shown in Figure 144 is an illustration of the results showing good mixing.
